Regulation at Hanford - A Case Study

A. R. Hawkins
Senior Technical Advisor
Department of Energy - Richland Operations Office

Date Published
September 2007

To Be Presented at
Challenges in Radiation Protection and Nuclear Safety Regulation of the Nuclear Legacy

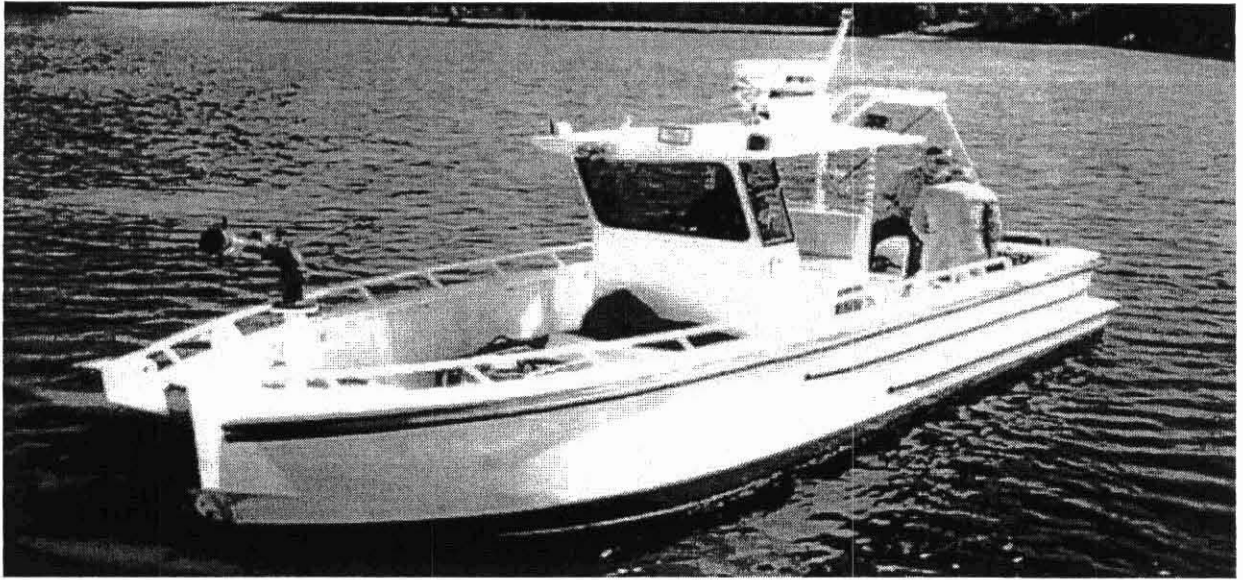
Figure 9 – Emergency Response Boat

The second SEP recognizes two-thirds of Benton County is bordered by the Columbia River. The total perimeter length of the Columbia River around Benton County is approximately 182 miles (292 kilometers). This SEP provides assistance to emergency planning and response organizations to help respond better to oil spills and hazardous substance releases to local rivers by providing two boats to local law enforcement. The SEP includes an agreement to form a response team of personnel from local agencies to respond to emergency incidents, including oil and hazardous substance releases, on the Columbia, Yakima, Walla Walla, and Snake Rivers. Figure 9 shows one of the two boats to be provided.
